# Manhole Inspection Summary

Manhole # S49A\_\_020MH

Insp Date: **6/10/08 1:11 PM**

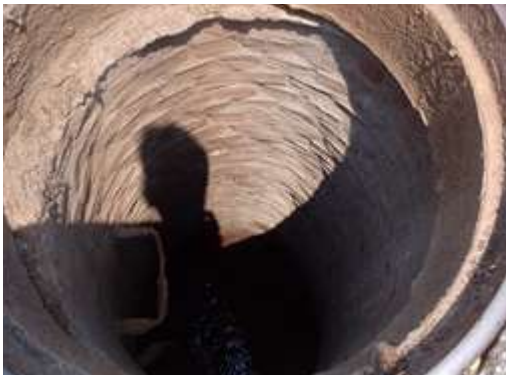
Defect 1

**Frame** Offset: **2** (in.) Condition: ☐ Sound ☐ Cracked ☒ **Leaks**

offset frame

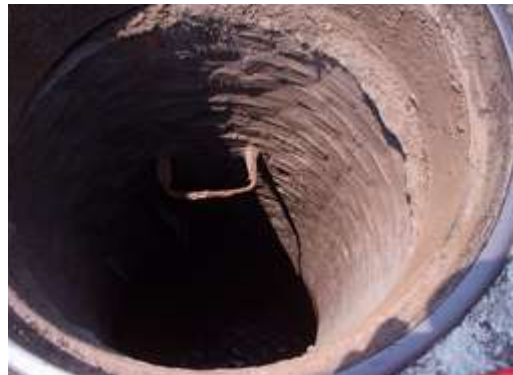
Defect 2

**Steps** Count: **8** Missing: **6** ☒ **Corroded**

deterioration, missing steps

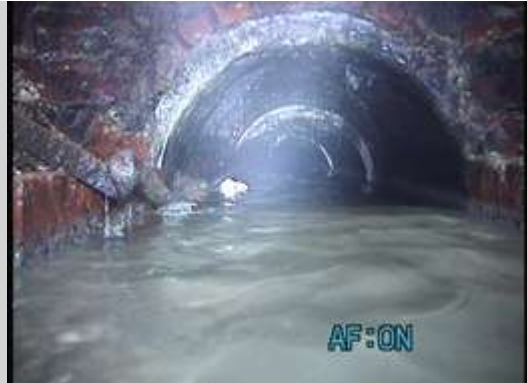
12 O'Clock Outflow

15 in. Circular Gravity Sewer  
Pipe Out @ 12 O'Clock

Pipe Height: **15.6** (in.) Rod and Bar (Angled)  
Pipe Material: **Clay** ☐ Pipe Lined  
Invert Depth: **14.10** (ft.) Flow Characteristics: **Fast**  
Deposits: ☒ None ☐ Mud ☐ Sludge ☐ Debris ☐ Grease  
Silt Depth: (in.) Deposits Extent:  
Infiltration: **None** Pipe Seal Cond: **Sound**

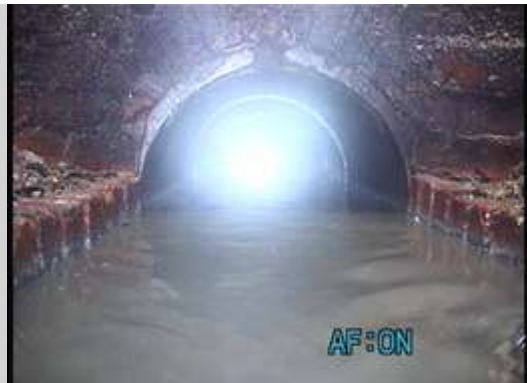
6 O'Clock Inflow

10 in. Circular Gravity Sewer  
Pipe In @ 6 O'Clock

Pipe Height: **10.8** (in.) Rod and Bar (Angled)  
Pipe Material: **Clay** ☐ Pipe Lined  
Invert Depth: **13.80** (ft.) Flow Characteristics: **Fast**  
Deposits: ☒ None ☐ Mud ☐ Sludge ☐ Debris ☐ Grease  
Silt Depth: (in.) Deposits Extent:  
Infiltration: **None** Pipe Seal Cond: **Sound**
